UNITED STATES ENVIRONMENTAL PROTECTION AGENCY

**RE: Request for Information (“RFI”) Pursuant to Section 308 of the Clean Water Act
Docket No. CWA-IR-16-009
On Time Ready Mix Inc. – 34-16 College Point Blvd Facility (NYR00D693)
Compliance Evaluation Inspection conducted on February 1, 2016**

COMPLIANCE EVALUATION INSPECTION REPORT

Compliance Evaluation Inspection: On Time Ready Mix Inc.	
Inspection Date: February 1, 2016	EPA Inspectors: Kimberly McEathron, Physical Scientist, USEPA Region 2, (212) 637-4228; and Cyndy Kopitsky, Physical Scientist, USEPA Region 2, (212) 637-3832
Inspection Time: 9:40 AM – 10:50 AM	
On-Site Representatives: Rocco Oppedisano, Plant Manager/Co-Owner, On Time Ready Mix Inc., (718) 961-3338; and Helen Hu, On Time Ready Mix Inc., (718) 961-3338	
Site Information: Lat / Long: 40.76433, -73.836525 On Time Ready Mix Inc. 34-16 College Point Blvd Flushing, New York 11354 SPDES/ICIS No. NYR00D693	
NAICS/SIC Code: 3273 – Ready-Mixed Concrete

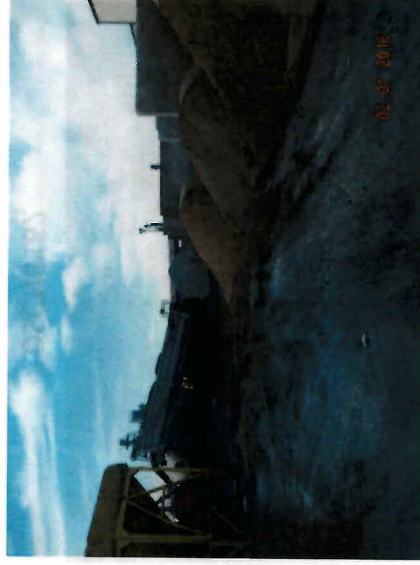
DSCN6160

DSCN6156.JPG	Close up of cement powder hook up with some powder visible
DSCN6157.JPG	Cement powder tanks
DSCN6158.JPG	Cement powder truck
DSCN6159.JPG	Sand pile, north driveway, view facing north
DSCN6160.JPG	Sand and stone piles along north side of facility
DSCN6161.JPG	Parking area across the street
DSCN6162.JPG	Truck loading area
DSCN6163.JPG	Sand and stone piles along north side of facility
DSCN6164.JPG	Sweeper
DSCN6165.JPG	Dumpster in southwest corner of facility
DSCN6166.JPG	Drums
DSCN6167.JPG	Southwest corner of concrete wall with cracks
DSCN6168.JPG	Southwest corner of concrete wall with cracks
DSCN6169.JPG	Southwest corner of concrete wall with cracks
DSCN6170.JPG	Southwest corner of concrete wall with cracks
DSCN6171.JPG	Southwest corner of concrete wall with cracks
DSCN6172.JPG	Southwest corner of concrete wall with cracks
DSCN6173.JPG	6 additional batteries outdoors exposed to stormwater
DSCN6174.JPG	Trench filled with solids and liquids

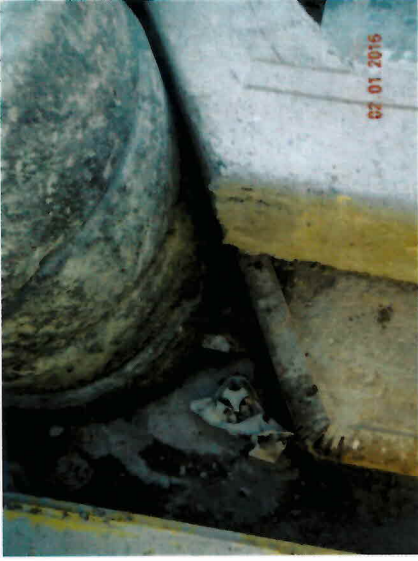
DSCN6170

At the time of the inspection, EPA observed that the concrete wall in the southwest corner was cracked and misaligned into multiple pieces (see photographs DSCN6167.JPG – DSCN6169.JPG and DSCN6172.JPG). EPA did not observe water pooling at or flowing through this location at the time of the inspection. According to Mr. Oppedisano, a barge operating at the Tilcon Facility hit the corner of the wall and damaged it.

1. At the time of the inspection, EPA observed that the concrete wall in the southwest corner was cracked and misaligned into multiple pieces (see photographs DSCN6167.JPG – DSCN6172.JPG). If future conditions at the Facility or surrounding areas, including but not limited to any additional degradation, erosion or damage to the concrete wall located along the western edge of the Facility or should the NYCDEP complete a sewer separation, where the conditions result in a discharge of stormwater or wastewater from the Facility to Flushing Creek, a water of the United States via a point source, NYSDEC SPDES permit coverage for the Facility is required to be obtained prior to discharging, in accordance with Sections 301 and 402(p) of the Clean Water Act.

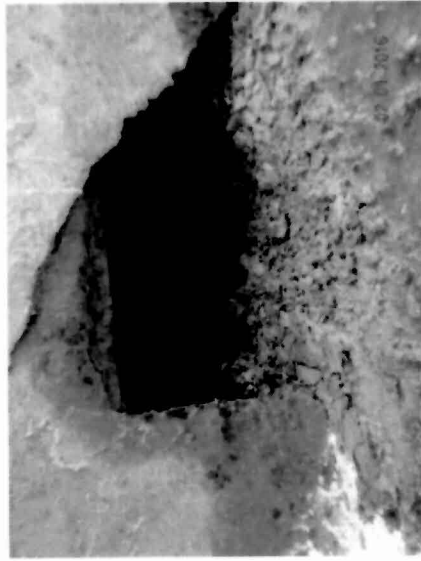
DSCN6179

At the time of the inspection, EPA observed a hole in the concrete wall at the north end of the Facility with pooling turbid water adjacent to it (see photograph DSCN6177.JPG). Utilizing a camera and metal rod, EPA identified that the hole was deeper than the width of the curb (see photographs DSCN6179.JPG – DSCN6182.JPG). At the time of the inspection, EPA observed water dripping into Flushing Creek from this location along the concrete wall and did not observe water dripping from any other location along the wall indicating that water was likely penetrating the wall from the observed hole (see photograph DSCN6183.JPG).

DSCN6175.JPG	Trench filled with solids and liquids
DSCN6176.JPG	West side wall facing north
DSCN6177.JPG	Filled in trench adjacent to stone pile and hole in concrete curb
DSCN6178.JPG	Manhole covered
DSCN6179.JPG	Close up of hole in concrete curb with light visible
DSCN6180.JPG	Close up of hole in concrete curb with light visible
DSCN6181.JPG	Metal rod in hole
DSCN6182.JPG	Metal rod showing depth of hole
DSCN6183.JPG	Water dripping from other end of hole into Creek

1. Within seven (7) calendar days of receipt of this RFI, On Time Ready Mix Inc. shall submit to EPA a signed written statement certifying that On Time Ready Mix Inc. sealed the hole in the north end of the concrete wall at the Facility adjacent to Flushing Creek as described in the enclosed inspection report; and
2. Within thirty (30) calendar days of receipt of this RFI, On Time Ready Mix Inc. shall submit to EPA a written description with photographic documentation of what measures On Time Ready Mix Inc. has taken to address each of the areas of concern noted in the enclosed inspection report. Specifically, measures to remedy the damaged and deteriorating concrete wall located at the southwest corner of the Facility adjacent to Flushing Creek.
